MONTHLY CONSTRUCTION REPORT TO FERC REPORT FOR APRIL 1 - MAY 15 2006

Work on the Falls Creek Hydroelectric Project commenced on April 3, 2006. Major items of work this month included cutting all trees for road right of way, power-house and borrow pits, and construction of the base for approximately one mile of access road. Three barge deliveries mobilized equipment and supplies from Juneau to Gustavus.

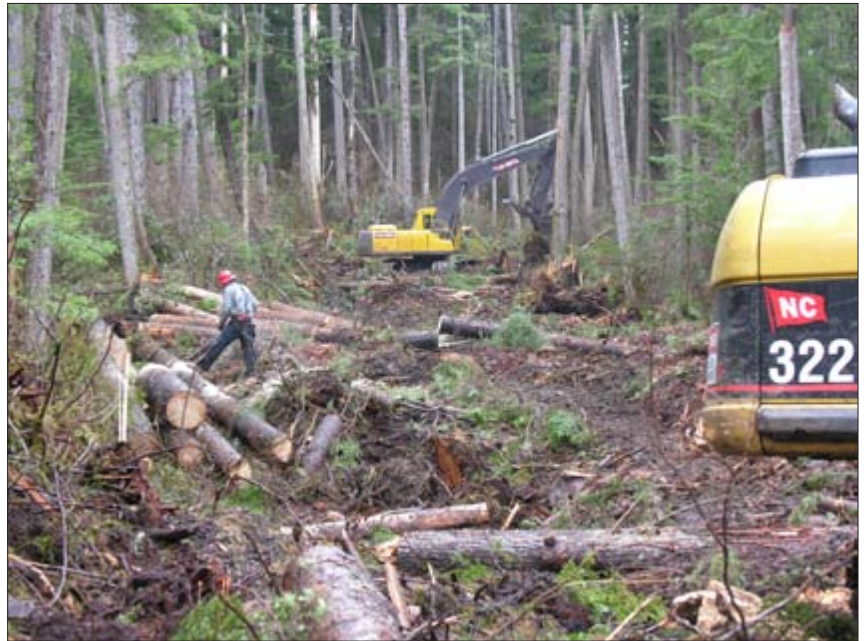
Road pioneering

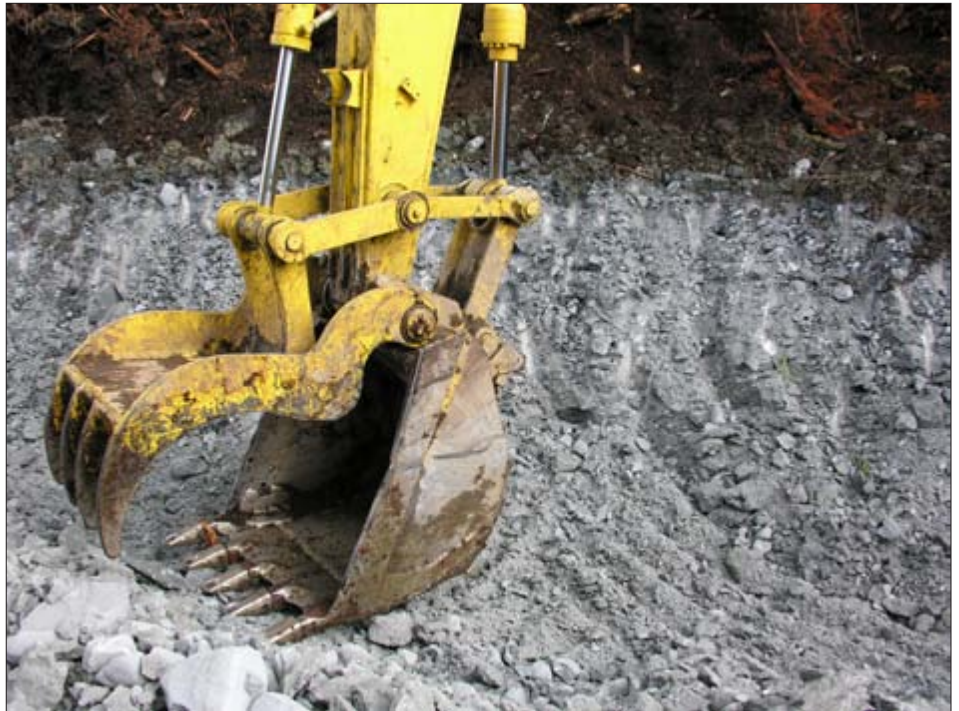
Photo showing the character (dry) of the lodgment till material available in pit 1 and pit 2.

Development of pit 1 and construction of the road base began shortly after right of way tree clearing commenced. The material provided by pit 1 (and pit 2) is a form of lodgment till comprised largely of blue clay, gravel, cobble and boulder. This material is particularly prone to the mobilization of silt during rain events and will need to be capped with layer of rock for stabilization. This material is also resulting in a larger than normal road prism base because it is highly compactible. The larger cut banks and back slopes will need to be covered by slope stabilization fabric and possibly hydro-seeded. Other areas will need topsoil dressing to increase the rate of local plant colonization.

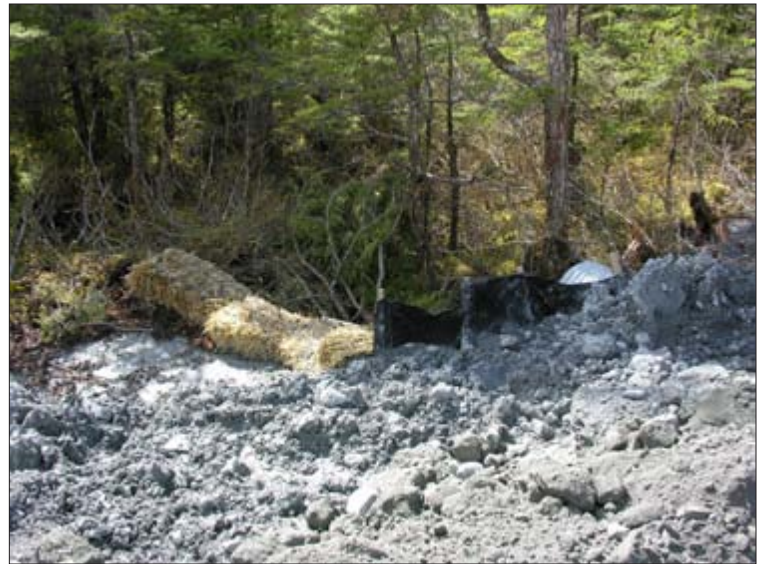
After road base construction and culvert placement had occurred up to the location of pit 2 the weather became very wet. This mobilized sediment along the road bed and necessitated the construction of sediment fencing and settling ponds at each culvert and stream crossing (See Figure 2 for culvert locations). These

Sediment control measures.

measures, along with grade improvements along problematic low spots, were very effective at controlling sediment. Little sediment entered the two anadromous stream crossings encountered thus far (Homesteader creek). In several other locations the mobilized silt has penetrated bordering forest up to 30 feet from the road bed but it is believed that the moss and root mat is minimizing further spreading of this material.

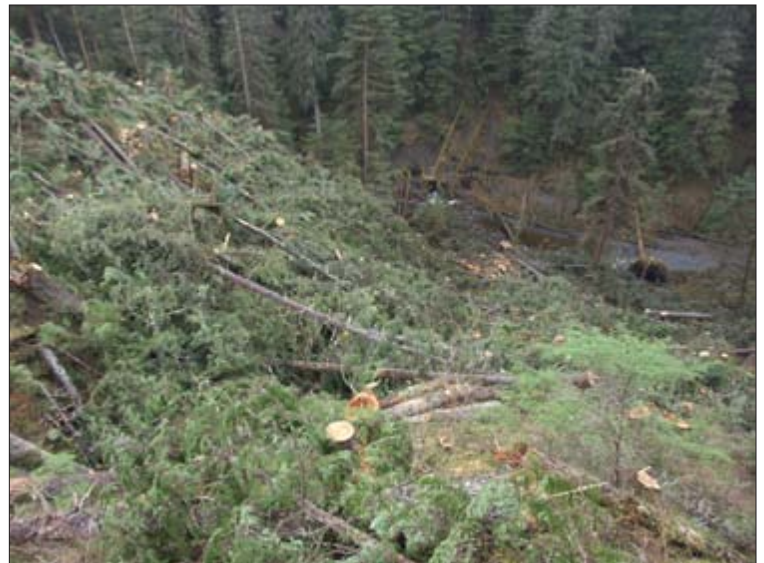
Impacts to murrelet habitat, bear habitat and other mammals that benefit from salmon availability are the greatest at the power-house site. The ECM met with the PM and CS on location prior to tree clearing operations to discuss possible alternatives and means to reduce impacts to habitat. An alternative power-house site was considered for reducing impacts to habitat but had to be abandoned because of not providing enough distance/ elevation change to maintain a safe and practical road grade.

Clearing at the power-house site.
